County of Santa Cruz
Department of Public Works

1999 - 2009

- ◆ Geotechnical investigation
- ◆ Geologic evaluation
- ◆ Structural analysis & design
- ◆ Preparation of plans, specifications & estimates

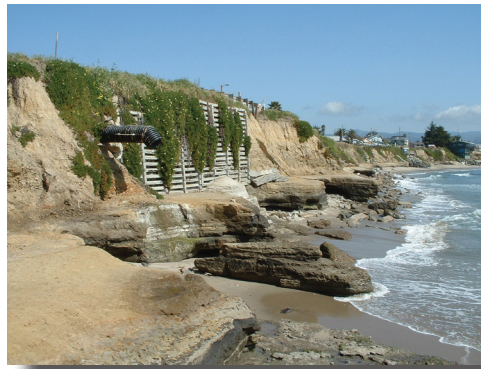
Before

In 1999, the County required emergency stabilization of three failing crib walls on the bluff along East Cliff Drive between 33rd and 36th Avenues. The walls were up to 18 feet tall, 30 feet long and exhibited severe structural distress. Imminent failure of these walls posed a significant risk to the roadway, underground utilities, and public safety.

SAGE provided structural design, plans, and specifications for emergency repair measures to provide immediate, local crib wall stability. To minimize construction impacts to the sensitive coastal bluff and ocean environment, we recommended that the crib walls be stabilized in place using soil nail walls. Specifically, our design included installation of “injection anchor” type soil nails extending approximately 20 feet behind the face of the crib walls, followed by application of a reinforced shotcrete facing over the crib wall facings and flanks. Injection anchors were selected to minimize cuttings and dust common to standard soil nail installation. Key design considerations included impact loading from wave-borne debris and outflanking of the soil nail walls.

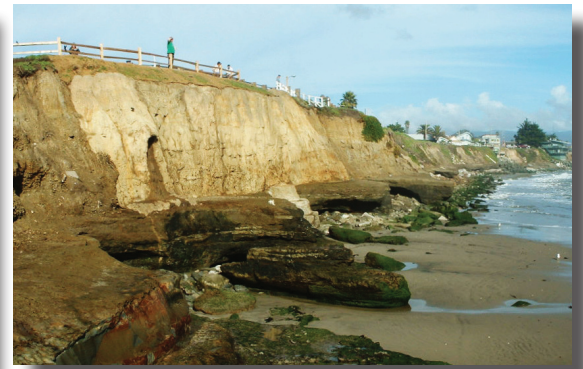
After stabilization and application of sculpted and stained shotcrete facing

To address aesthetic considerations along the scenic corridor, SAGE researched specialty contractors skilled in sculpting and staining of shotcrete to replicate the surrounding bluff materials. Research included interviews and field trips with County personnel to view finished walls. SAGE also provided full-time observation during construction to confirm that field conditions were consistent with our design assumptions and help to verify contractor conformance to the plans and specifications.

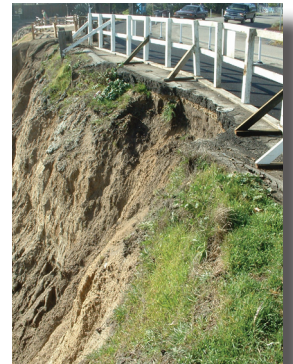
In support of the Coastal Development Permit (CDP) application submitted to the California Coastal Commission (CCC), SAGE prepared preliminary structural design plans for soil nail walls and performed a coastal bluff evaluation to more precisely define the degree of threat to East Cliff Drive and critical underground utilities with respect to ongoing coastal erosion. Our geologists documented existing bluff conditions and estimated maximum episodic bluff failure size and frequency using historic aerial photographs and maps. SAGE also performed slope stability analyses to estimate the largest potential episodic bluff failure and factors of safety against bluff failure for static and seismic conditions. Based on the results of the coastal bluff evaluation and the slope stability analyses, we estimated the degree of threat to the existing improvements and assigned specific sections of the roadway to one of three numerical threat zones. In light of these threat estimates and after reviewing our preliminary structural design plans for soil nail wall stabilization measures, the CCC approved the County's CDP application in December 2007.

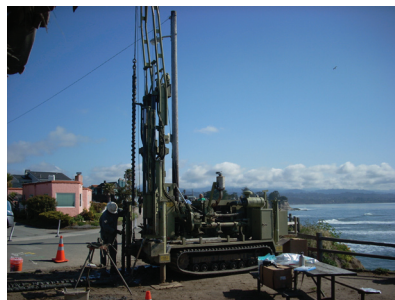
SAGE recently completed the final geotechnical investigation report, and final structural design plans, specifications, and estimates for construction of the soil nail walls. Project challenges included design of integrated stairways at three locations, and mechanically stabilized earth (MSE) build-out areas to create scenic overlooks and/or to rebuild areas where the existing roadway has been lost to erosion. Our engineers have worked closely with the County to locate beach access staircases, scenic overlooks, and escape routes for surfers stranded at the base of the bluff during high tides. Construction of the project commenced in May 2009.
